# Extant Roofing Pattern and Early Decay of Residential Buildings in Port Harcourt Municipality, Rivers State

Esau, James Esau<sup>1,\*</sup>, Pepple, Tonye, Dagogo<sup>2</sup>

**Citation:** Esau, James Esau, Pepple, Tonye, Dagogo. Extant Roofing Pattern and Early Decay of Residential Buildings in Port Harcourt Municipality, Rivers State. International Journal of Environmental Planning and Development Architecture. 2025; 3(2): 16–24p.

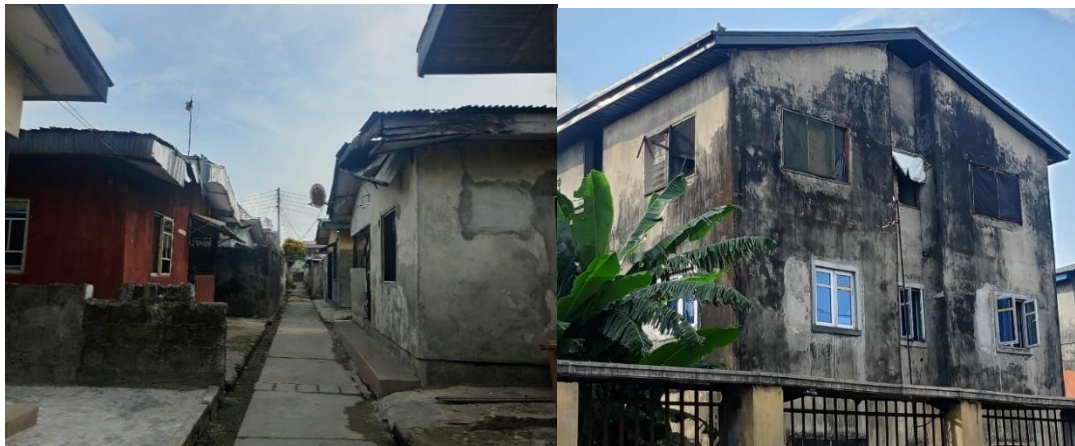
The depth of roof overhang was observed to be inadequate and a major contributor to the early decay of other building component, the study shows that buildings in Port Harcourt Township with 113 buildings out of 161 making (69.89%) fails within buildings with 000 to 600mm eave depth, Oromenike with (65.45%), and Mgbundungwu with (66.22%) all have a eave depth of 000 to 600mm depth which show the high level of poor design consideration for our local climate and the importance of roof eave as major element that gives cover to the external walls and other components (Dilshan, Roshida and Mohd, 2008) see table 3 and figure 5. ). Similar problems were also recorded on the roof angle (pitch) were majority of the buildings in the study area has elevated roof pitch between  $11^{\circ}$  to  $15^{\circ}$  which is classified as a flat roof and not recommended for buildings in the study area (Allen, 1938) [3]. Dilshan, Roshida *et al.* (2008), in Port Harcourt Township making 43 buildings (26.88%), Oromenike (27.27%), and Mgbundugwu with 29 buildings with 32.38 all having  $11^{\circ}$  to  $15^{\circ}$  as the roof angles are almost flat and not adequate for easy runoff of water and poor elimination of heat and water vapor in the roof space and building (Duncan, Derek & Rogers, 2003) [6] (see Table 4 and Figure 5).

**Figure 5.** Showing roof decay and impact on other component in port harcourt township and inadequate eave cover with a corresponding decay on external walls in mgbunbungwu neighbourhood.
