Catalyst-Driven Degradation and Failure Analysis of Intergranular Cracking in 316H Studded Pipes under Refinery Heat Recovery Conditions

A failure analysis investigation was carried out on a high-temperature studded pipe used in a convection module for heat recovery in an oil and gas refinery application after leakage was detected during pre-commissioning hydrotesting. The investigated pipe was manufactured from AISI 316H austenitic stainless steel, and carbon steel studs had been joined to its outer surface by high-frequency resistance welding. Two leaks were reported in the pipe under investigation, and a sample containing one leaking region was removed for detailed examination. The failed sample was examined by visual inspection, dye penetrant testing, optical emission spectroscopy, stereomicroscopy, metallographic sectioning, scanning electron microscopy, and energy-dispersive spectroscopy. The leak was associated with a longitudinal crack that propagated through the pipe wall thickness and exhibited a predominantly intergranular morphology. Metallographic examination further showed that one end of the crack was located at a lack-of-fusion region between the stud and the exter

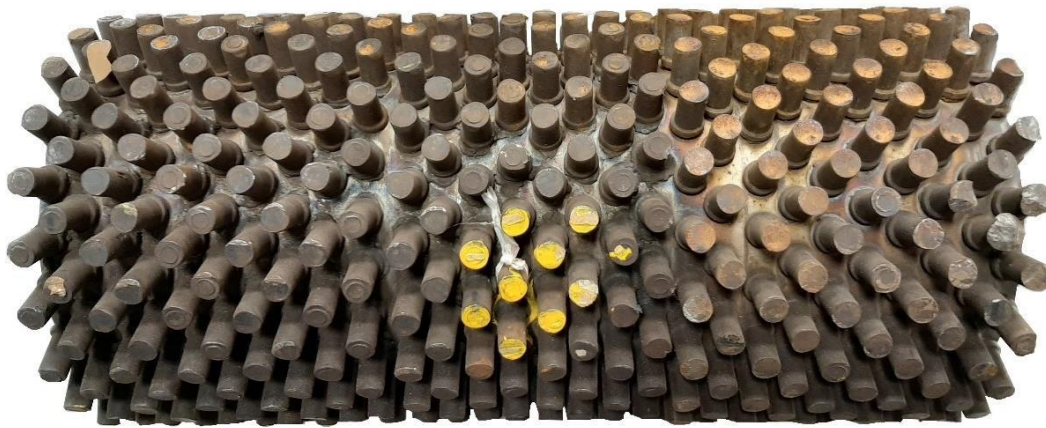
Figure 1: Studded pipe sample, as received

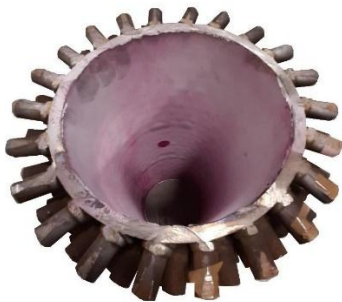
Before sectioning, the internal surface of the pipe was cleaned and then subjected to dye penetrant inspection. The penetrant test confirmed the presence of one surface-breaking indication in the investigated region. The indication was linear in morphology and consistent with a longitudinal crack. In addition, the pipe exhibited localized bulging along circumferential regions near the crack location (Figure 2 & 3).

Figure 2: Pipe sample with dye penetrant inspection

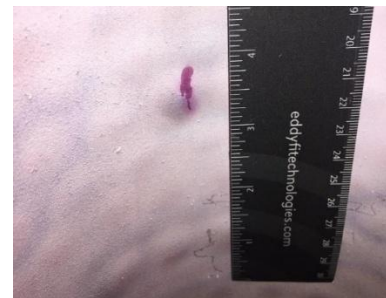
Figure 3: Condition of the pipe internal surface

Visual examination and dye penetrant inspection confirmed the presence of a longitudinal, surface-breaking crack at the leaking location. The crack was associated with localized bulging in nearby circumferential regions. These observations indicated localized mechanical or thermal damage in the region rather than generalized degradation of the entire pipe wall. The internal pipe surface also exhibited heat tint near the damaged area. The presence of heat tint, together with the observed bulging, suggested that the region had experienced a localized thermal excursion during fabrication or processing.

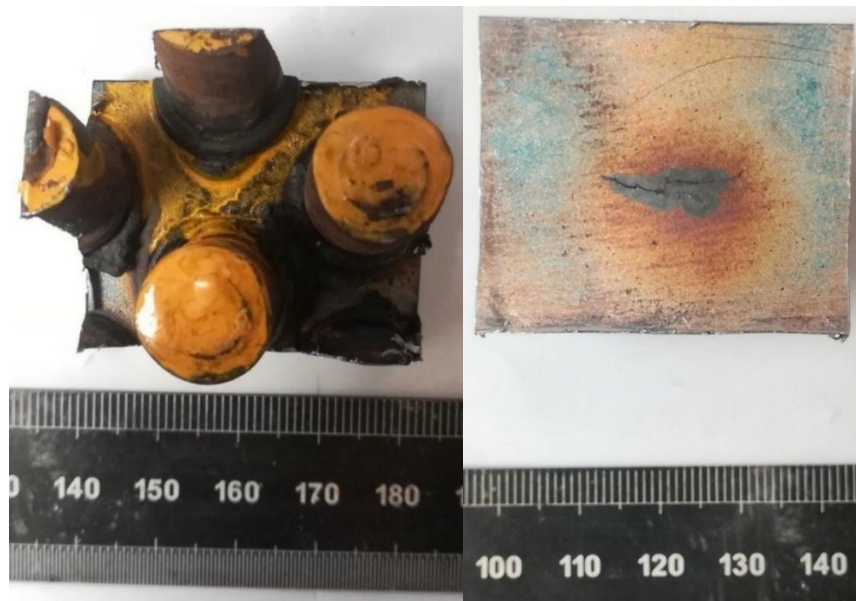
Figure 4: Crack location on the external (a) and internal (b) surface.

A general view of both sides of the sample, selected for further investigation, is shown in figure 4. In detail, the crack location is marked in figure 4a and 4b for the external and internal surface, respectively. As evident in figure 4b, the pipe surface exhibits heat tints (Figure 5 & 6).

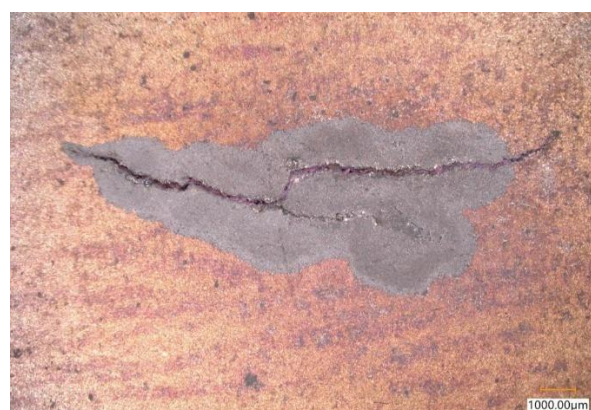
Figure 5: Additional close-up locations on the internal surface, x7.

A general view of the crack path, as better visible by stereomicroscopy, is shown in figure 5 and 6 close-up view of the crack. As shown in the close-ups below, the internal surface exhibits an intergranular pattern (Figure 7 & 8).

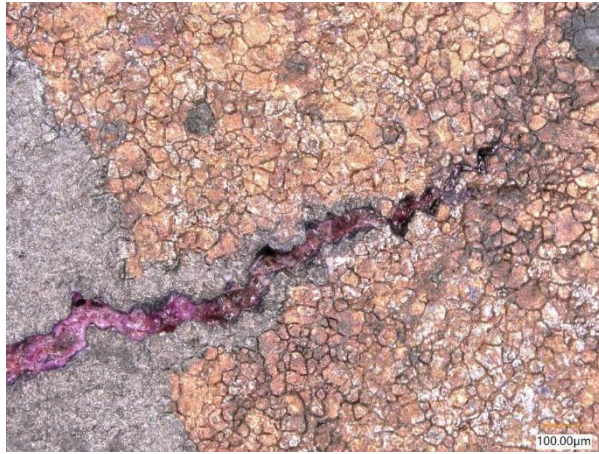
Figure 6: Additional close-up on the internal surface, x70.

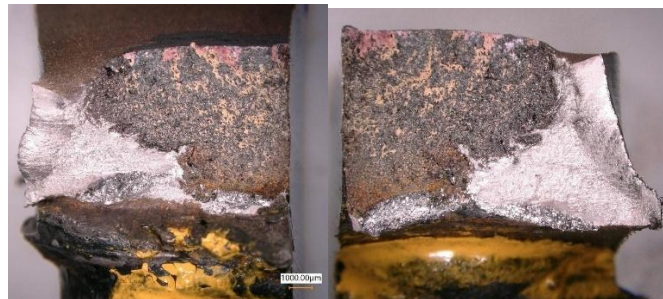
Figure 8: Matching fracture surfaces.

Micro sectioning was carried out as illustrated in figure 7. As visible below, the right portion of the crack was forced open to allow stereo and SEM fractography (figure 8). The remaining part of the crack was used for metallographic examination along the transverse direction. Two views of the crack propagation path, with respect to the stud positioning and welded joint was investigated for crack propagation pattern to study.

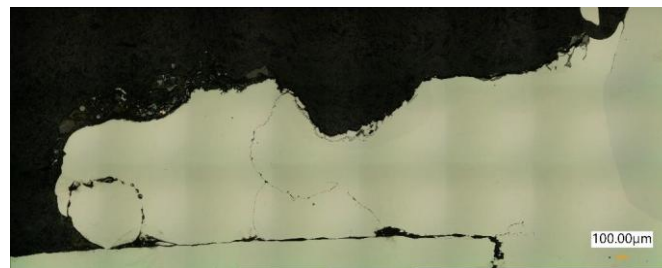
Figure 9: Contact area between the stud and the pipe

Metallographic examination of the section taken transverse to the leak showed that the main crack extended across the pipe wall thickness. One end of the crack was located at a lack-of-fusion region between the right stud and the external surface of the pipe. This observation is important because it associates the crack directly with the stud attachment zone. The crack path was found to be predominantly intergranular in nature. In addition, a copperish-colored matter was observed along the internal surfaces of the crack. The surrounding microstructure of the pipe was considered consistent with the expected condition of the austenitic grade under investigation.

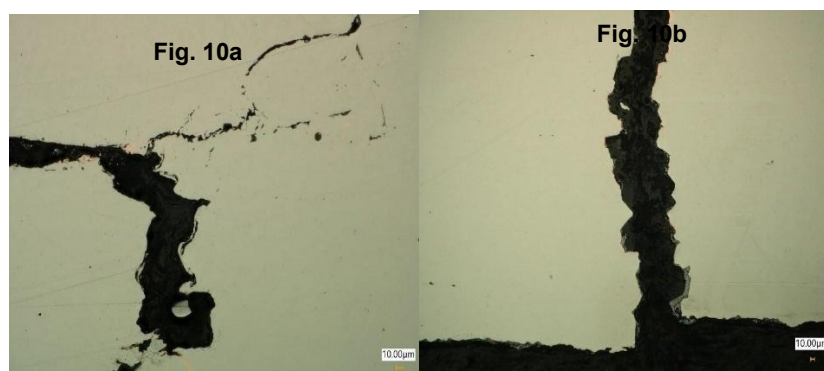
A representative microsection from the cracked region was prepared and examined before and after etching. The selected cross-section was taken transverse to the leak and was intended to show the relationship between the crack path, the pipe wall thickness, and the stud attachment area. Additional micrographs were recorded to assess crack morphology and the condition of the surrounding microstructure. An additional microsection was also cut from a region away from the leaking area. This was done to determine whether similar cracking or contamination features were present elsewhere in the sample. A general view of the selected area is visible in figure 8 where the regions subjected to observation are illustrated. As evident below, the main crack path runs transversally through the pipe wall thickness with one end located at the lack of fusion between the right stud and the pipe external surface (figures 9 and 10b). Additional micrographs of the cracked area are verified prior and post etching respectively. Based on the metallographic evidence, the crack path appears to be predominantly intergranular in nature. Presence of a copperish-coloured matter was also observed along the crack internal surfaces (Figure 9 & 10).

Figure 10: Cracked area condition prior etching.

9. Further investigation into the origin and transfer mode of copper contamination was strongly recommended.
