# Assessment of Operation and Maintenance Issues in the Rainwater Harvesting Systems of Residential Apartments Built in the Last Decade: A Case Study of Pune

*Despite abundant rainfall, Indian metropolitan centres, including Pune, face severe water crises due to inadequate stormwater management. In response, governmental bodies and sustainable rating frameworks have mandated the integration of rainwater harvesting (RWH) systems within the built environment. However, a significant policy-practice gap persists while RWH systems are frequently installed to meet regulatory compliance, they often fail to achieve their operational objectives due to severe maintenance and functional deficits. This study investigates these persistent performance gaps by analyzing RWH implementations in mid-rise residential apartments built in Pune over the last decade (2015–2025). Employing a rigorous mixed-methods approach, the research utilizes QGIS and Google Earth Pro for spatial mapping and temporal analysis to identify highly water-stressed urban zones. From this analysis, sixteen residential buildings were systematically shortlisted based on building height, construction timeline, geographic vulner

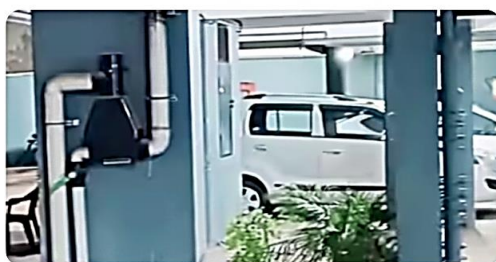
Rainwater harvesting system at Windsor Avenue building in Wanowrie. The system helped society become tanker-free

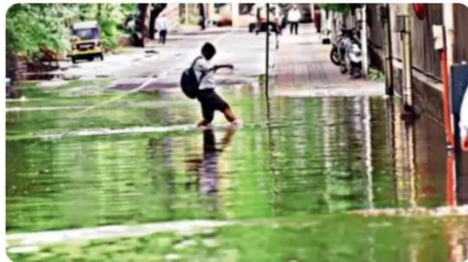
<p>Rainwater harvesting diverts rain into pits that recharge groundwater. Currently, only 5-8% of an estimated 10 lakh...
