# Detection and Assessment of Structural Weaknesses in Existing Offshore Structures

**Table 1.** Test results of visual inspection test

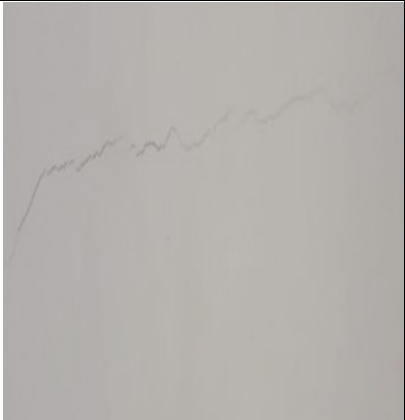
| S.N. | Site name | Location | Condition | Picture | Method for repair (recommendations) |
|---|---|---|---|---|---|
| 1 | Anukul Nivas, Deolai Chowk, Chhatrapati Shivaji Nagar, | C1, C2, C3, C4, C5, C6, C10, C11 | Minor cracks have been observed, and the rebound values are low. | | Apply a coat of polymer-modified cement-based putty or crack sealant for durability and surface protection. |

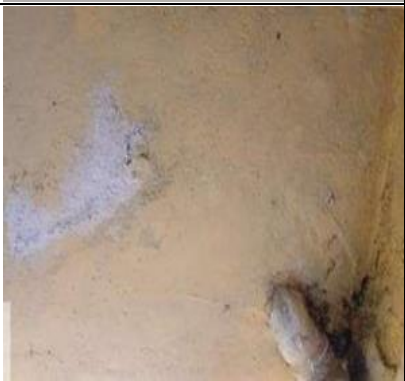
| S.N. | Site name | Location | Condition | Picture | Method for repair (recommendations) |
|---|---|---|---|---|---|
| | | Bedroom Slab | Bedroom Slab | | Apply waterproofing treatments using elastomeric coatings or cementitious waterproofing to prevent moisture ingress. |

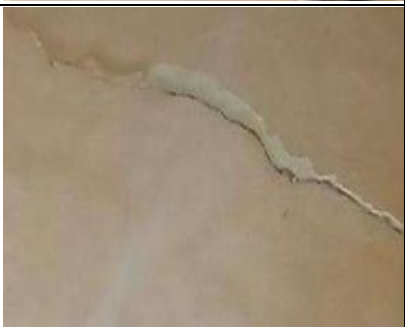
| S.N. | Site name | Location | Condition | Picture | Method for repair (recommendations) |
|---|---|---|---|---|---|
| | | C4, C5, C6, C7 | Major diagonal cracks are found near the column. | | Use epoxy injection for non-structural cracks and structural strengthening. |

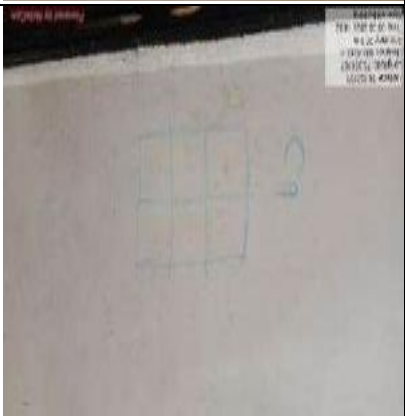
| S.N. | Site name | Location | Condition | Picture | Method for repair (recommendations) |
|---|---|---|---|---|---|
| | | C8, C9, C12 | Columns have medium rebound values. | | Apply micro-concrete or polymer-modified mortar to restore column integrity and improve compressive strength. |

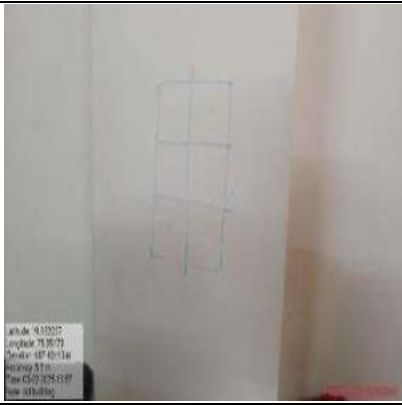
| | | C10 | Very low rebound values have been recorded. | | Strengthen the column using concrete jacketing or steel encasement to restore load-bearing capacity. |

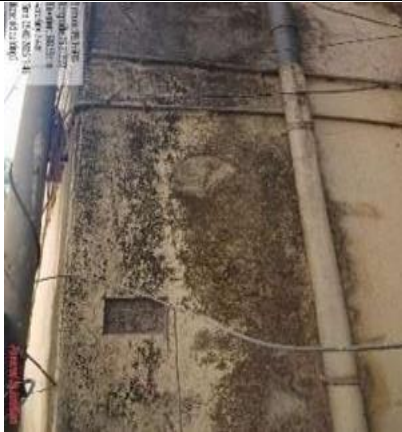
| 2 | MHADA housing society near VITS Hotel, Building No. 7 | C1, C2, C3, C4 | Concrete spalling, major diagonal cracks, and algae formation are present. | | Concrete spalling is when the surface layer of concrete breaks or chips off, often exposing the steel reinforcement inside. To fix this, all loose and damaged concrete should be removed first. The exposed steel bars must then be cleaned and coated with an anti-corrosive material to prevent rust. After that, the area should be filled and repaired using micro-concrete or a polymer-modified mortar to restore the surface and strength. |
