A review of nanocomposite coatings for marine applications

Abstract: This paper reviews the performance and material characterization of nanocomposite coatings on the hydraulic pipelines of Ship A-Frame, which were corroded due to seawater exposure. Hydraulic pipe lines made of carbon steel face severe corrosion due to the highly corrosive nature of seawater with high salinity and microorganisms. The shipping industry utilizes organic and inorganic coatings to safeguard the hydraulic and seawater pipe lines of deck machines from marine pollution. High hydraulic pressures cause corrosion of A-Frame and scientific winches, potentially reducing the service life of corroded hydraulic pipe lines. Various environmentally friendly coating techniques, including epoxy resin, FBE (fusion-bonded epoxy), AE (asphalt enamel), neoprene, and multilayer PE (polyethylene), PP (polypropylene), and PU (polyurethane), are widely used for pipeline coating. Nanocomposite coatings can be created using a diverse range of matrices and reinforcement materials. The corrosion control of nanocomposite coatings relies on the preparation and use of various matrices as their main component. Marine applications s

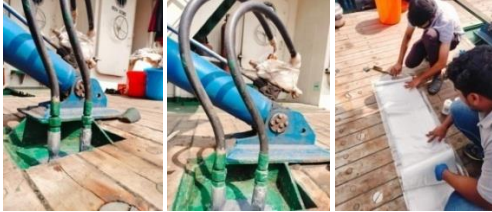
Figure 1: Side A-Frame Pipe Line
(Corrosion Identified Area)

The experiment utilized rapid-curing paste materials consisting of epoxy resin (A) and a hardener (B) as the materials. Figure 1 depicts a side A-frame pipe line with a corrosion identified area, and Figure 2 shows that the engine room pipe line has been identified as a potential area for corrosion.

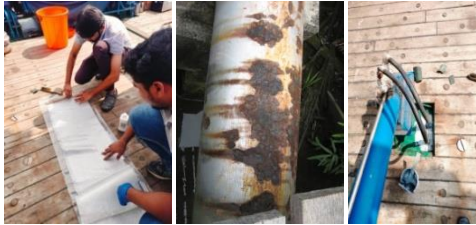
Figure 5. Coating on corroded pipeline

The Figure 5 depict the NPs Coating Work in Progress

The Coastal research vessel (CRV) conducted an experimental analysis on the composite material coating on the hydraulic pipe line of the A-Frame. The performance of the coating material was evaluated using various characterization techniques available in the onboard laboratory. The ship's engine room and deck sides were inspected for hydraulic and seawater-corroded pipe lines. The pipeline was coated using a rapid-curing epoxy paste composite material [6-8].

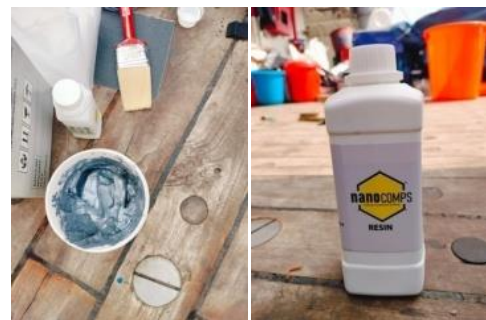
Figure 6: Rapid curing paste

marine environments despite the use of marine-grade paint. The side A-frame of the hydraulic pipe lines is coated with rapid curing paste material, as depicted in Figure 6[9-10].

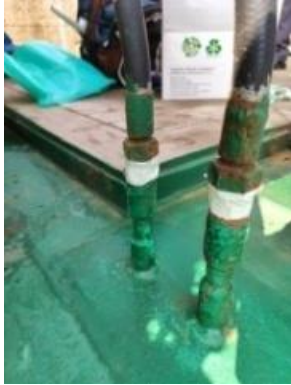
Figure 5: Before coating

An experimental analysis of pipeline coatings on board a pipe was successfully conducted. Implementing this approach on all research ships can significantly decrease dry dock repair and maintenance costs. The hydraulic pipe lines' side A-frame is coated with rapid curing paste material before and after the coating, as shown in Figures 6 and 7.
