# Effectiveness of Concrete Retrofitted with FRP Wrapping Subjected to Higher Temperature

*This work aims to provide additional insight into the behavior of fiber-reinforced polymer (FRP) laminates at high temperatures. The compressive properties of concrete coated in fiber-reinforced polymer (FRP) under elevated heat levels. The study addresses the important issue of assessing the performance of structural elements, specifically concrete columns, in the event of a fire. Recently, there has been increased interest in fiber-reinforced polymer (FRP) composite materials as a possible concrete structural rehabilitation solution. The purpose of this study was to ascertain, using both destructive and non-destructive methods, how fire damage affected concrete specimens retrofitted with Aramid FRP, Carbon FRP, and Glass FRP laminates. After being exposed to 250, 500, and 750°C for one, two, and three hours, the cube specimens were retrofitted with FRP laminates. In order to maximize the performance of concrete structures under harsh circumstances, the research highlights the significance of taking into account both the mechanical and fire-resistant qualities of retrofitting materials. The

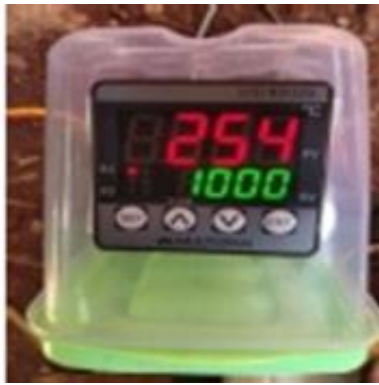
**Figure 2.** Thermocouple.

For this investigation, the first case (air cooling at room temperature) is favored. Refractory bricks were used to build a furnace for fire treatment. Figure 3 illustrates how cube specimens were burned (ISO 834, standard fire curve) with a high-speed burner. As seen in figure 2, a 'K'-type thermocouple was utilized to measure temperature using a UTC-4202 model temperature controller device. Specimens were subjected to fire for one, two, and three hours at a time. Before the cube specimens were cooled, the temperature range was measured.

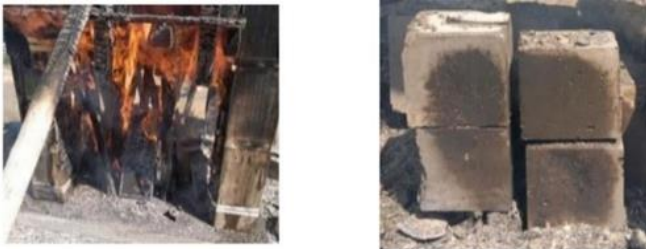
**Figure 3.** Exposure of fire on concrete cubes

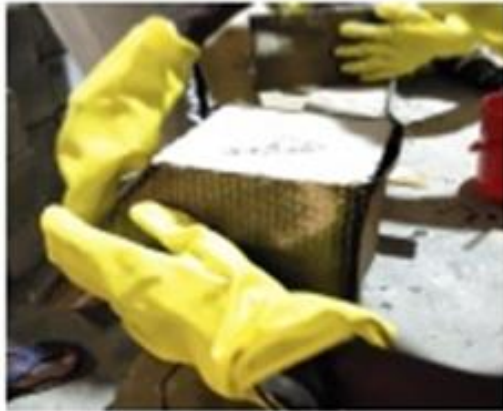
**Figure 4.** Wrapping of FRP

After being taken out of the furnace and let to cool, the specimens were roughened all over before being cleaned and wrapped. On the matching sides of each cube, an adequate amount of epoxy resin was metered out and applied uniformly. The FRP wraps are cut to the necessary cube dimensions. While wrapping, air pockets are prevented with the use of rollers. Figure 4 shows how FRP is wrapped around a concrete cube. The cyanoacrylate glue is left undisturbed to dry for a maximum of 48 hours. The necessary tests are run when the material has dried. The FRP sheets were wrapped in compliance with the ACI440-2R and ISIS manuals, perpendicular to the direction of the load.
