# Use of Geopolymer Composites for Controlling Structural Cracks

**Citation:** Rajesh Kumar, Vanita Aggarwal, S.M. Gupta. Use of Geopolymer Composites for Controlling Structural Cracks. Journal of Polymer & Composites. 2024; 12(Special Issue 6): S172–S184p.

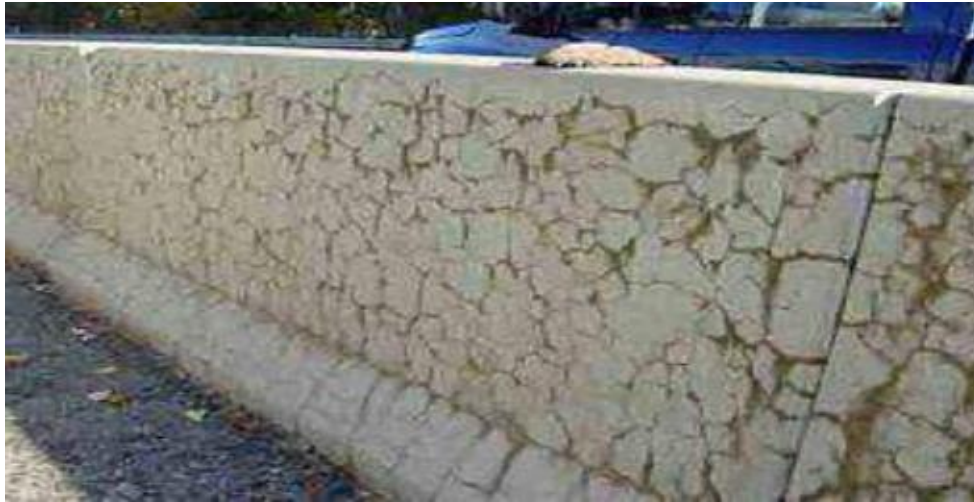
**Figure 4.** Typical Effect of Alkali-Aggregate Reaction.

The ASReffect (Figure 4) can be detected by physical appearances like concrete expansion and cracks affecting its structural elasticity, durability and strength, spalling of concrete, visible map cracking, and discharge of alkali-silica gel.

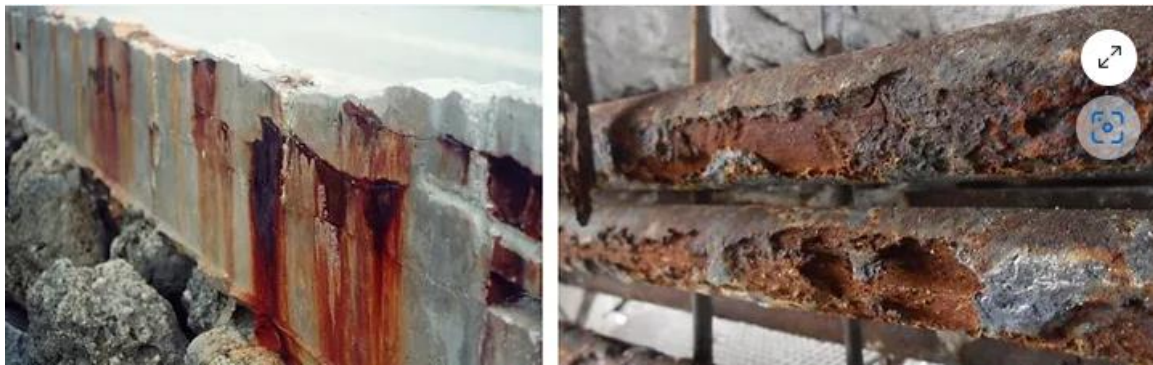
**Figure 6.** Chloride Attack Effects over Concrete and Reinforcement Steel.

Steel corrosion causes concrete cover spalling, causing porous oxide that takes up to 10 times the steel volume, leading to concrete break-up [24]. Horizontal cracks in material interface cause concrete cover loss due to oxide formation, while vertical cracks occur when steel's tensile strength exceeds. If rust stains are identified around spalls and cracks, these are symptoms of a chloride attack (Figure 6).

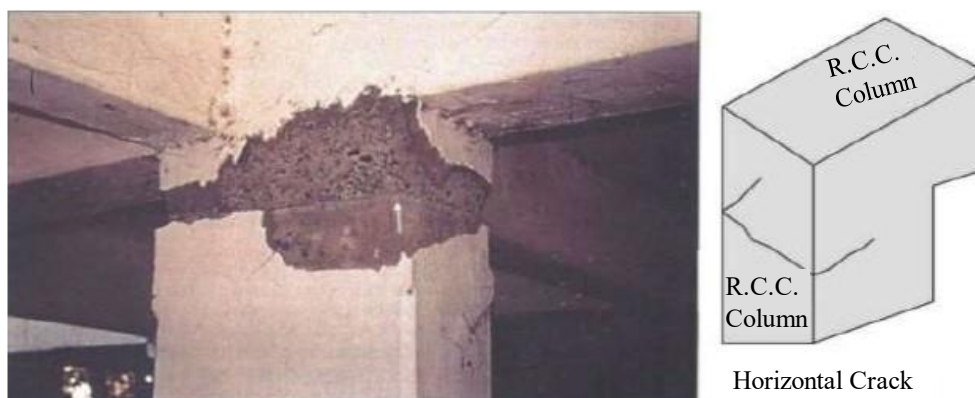
**Figure 8.** Horizontal Cracks Due to Moment Resistance.

| Member | Crack Type | Important Characteristic | Possible Reasons |
|---|---|---|---|
| Reinforced Concrete | Horizontal Cracks | Develop near Beam-Column junction | Insufficient moment resistance capacity of the column. |
| | | | Insufficient volume of reinforcement or placement of reinforcement not satisfactory |

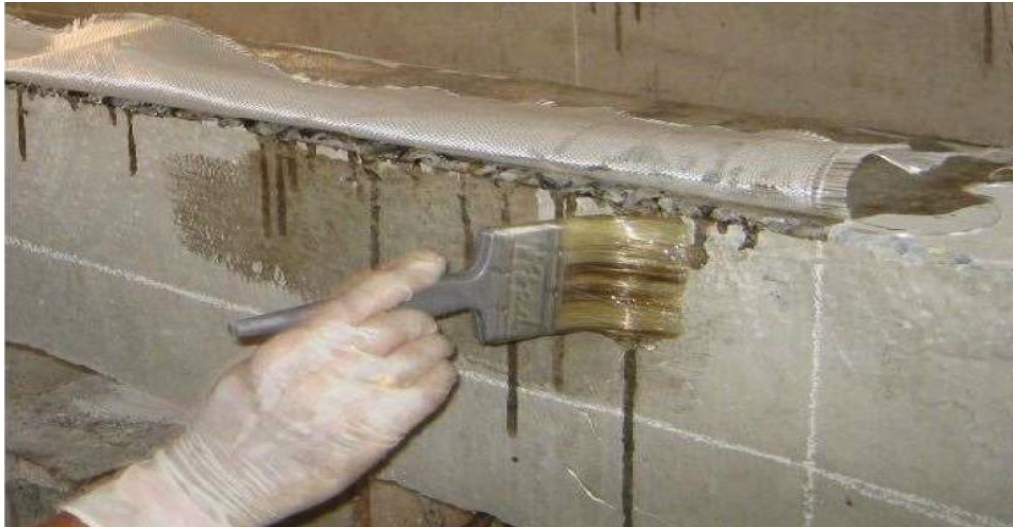
**Figure 12.** Application of Primer Coat or Coupling Agent.

The column's surface should be roughened, cleaned with an air blower, then grinded before being cleaned with a high-pressure air jet. The technique called wet lay-up is to be used to wrap the FRP layers. In this technique, an iso-phthalic polyester resin is applied to the concrete column surface. Next, to cover the resin, the dry fibrous reinforcement material is wrapped all around. Remove the entrapped air bubbles by using a roller and press the resin to penetrate properly into the fabric. The roller is to be continuously used until the resin reflects on the fabric surface, a sign of fully wetting. Another layer of resin is applied on the top of the fabric. This process accomplishes one FRP repair layer. The process is to be repeated to apply subsequent layers. The wrapped sample was then left at room temperature to permit the curing of the bonded laminates. All the procedures are represented in Figures 12, 13, 14, and 15.

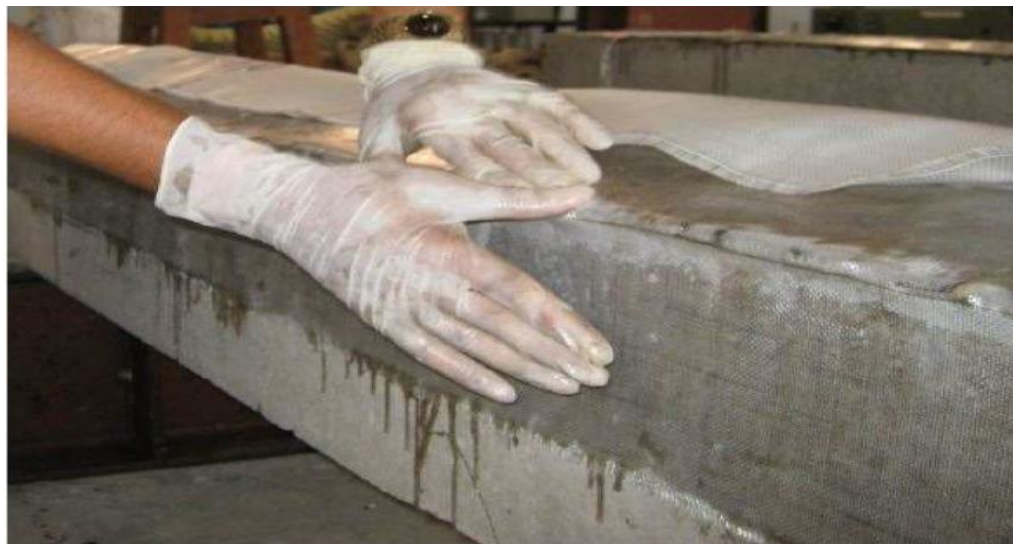
**Figure 13.** Application and Fixing of GFRP.

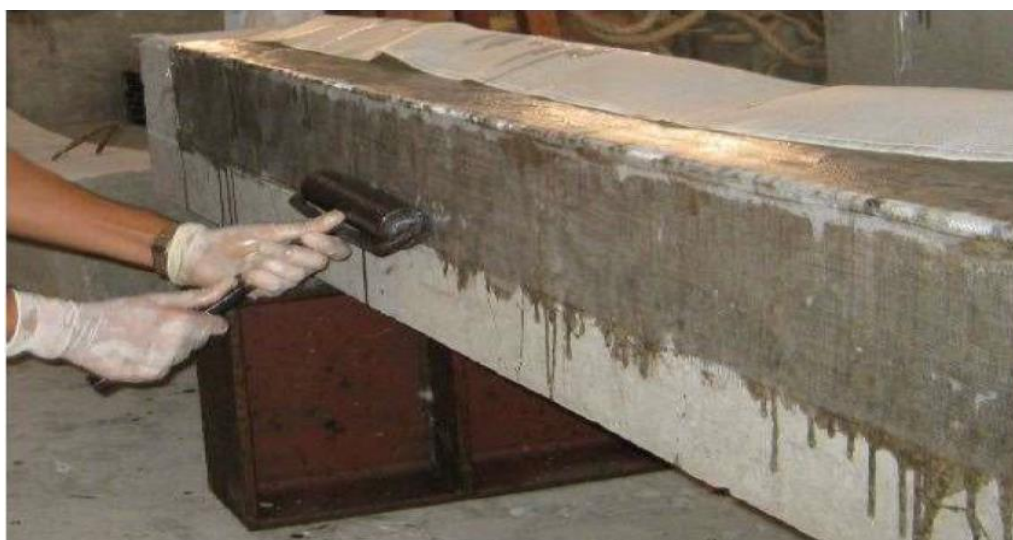
**Figure 14.** Removal of Entrapped Air.
