Catalyst-Driven Degradation and Failure Analysis of Intergranular Cracking in 316H Studded Pipes under Refinery Heat Recovery Conditions

A failure analysis investigation was carried out on a high-temperature studded pipe used in a convection module for heat recovery in an oil and gas refinery application after leakage was detected during pre-commissioning hydrotesting. The investigated pipe was manufactured from AISI 316H austenitic stainless steel, and carbon steel studs had been joined to its outer surface by high-frequency resistance welding. Two leaks were reported in the pipe under investigation, and a sample containing one leaking region was removed for detailed examination. The failed sample was examined by visual inspection, dye penetrant testing, optical emission spectroscopy, stereomicroscopy, metallographic sectioning, scanning electron microscopy, and energy-dispersive spectroscopy. The leak was associated with a longitudinal crack that propagated through the pipe wall thickness and exhibited a predominantly intergranular morphology. Metallographic examination further showed that one end of the crack was located at a lack-of-fusion region between the stud and the exter

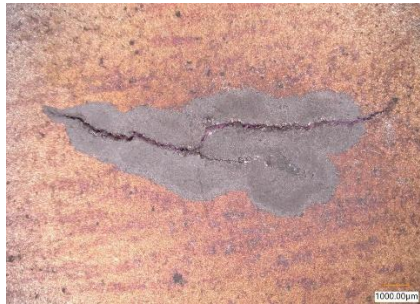
Figure 7: Cutting plan for micro sectioning.

Micro sectioning was carried out as illustrated in figure 7. As visible below, the right portion of the crack was forced open to allow stereo and SEM fractography (figure 8). The remaining part of the crack was used for metallographic examination along the transverse direction. Two views of the crack propagation path, with respect to the stud positioning and welded joint was investigated for crack propagation pattern to study.
